Water Rate Study 2021

This Water Rate Study (Study), prepared by Vista Irrigation District (District) staff, resulted in the recommended water rate structure and water rates.

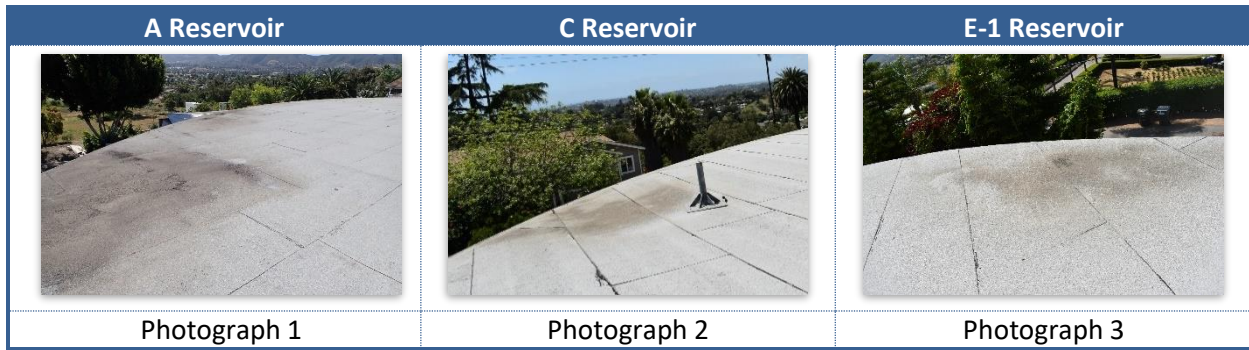
In general, the roof top surfaces were noted to be in poor to fair condition. The roofs are flat and consists of a built-up membrane. Visible sagging and evidence of ponding along the roof edge was observed throughout the roofs (see Photographs 1-3 below). When walking on each of the roof surfaces, it was noted to be very “springy” with areas of excessive deflection, indicating the sheathing is undersized for the framing spans or there may be damage to the sheathing or underlying framing. A Reservoir was noted to be considerably more springy than C and E-1 Reservoirs. The underlying diaphragms as observed from the interiors comprised of straight lumber sheathing on C and E-1 Reservoirs which likely contributed to the more firm walking surface, as the diaphragm at A Reservoir was observed to consist of structural sheathing. Based on the provided Santa Fe Roofing invoice number 2646 dated 6/19/2006, we understand the roof of C Reservoir should consist of 7/16” roof sheathing panels with a three-ply built-up hot mopped roof system. As part of work, we understand District Staff repaired damaged roof members prior to the installation of the new roof system atop the straight lumber sheathing of C Reservoir in 2006.

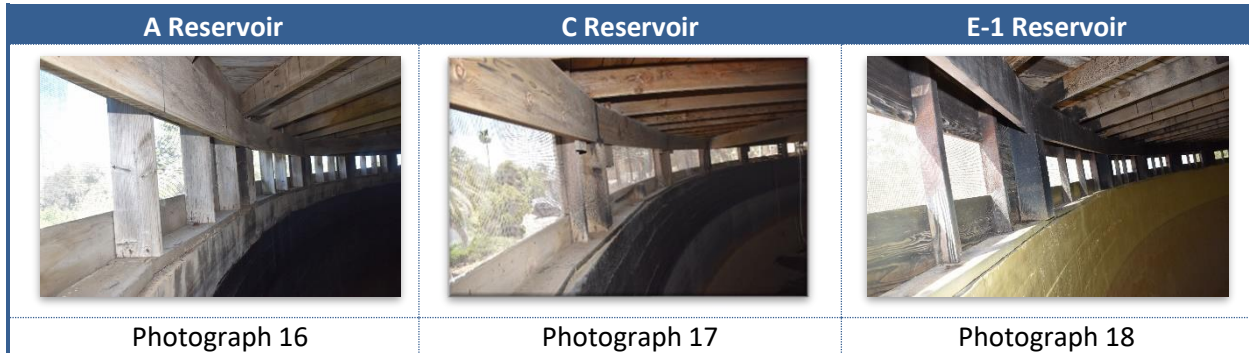
The Infill walls were noted to be in generally poor to fair conditions. The infill walls consist of a 2x8 sill plate, 8x8 posts (6x6 post at C Reservoir), and 2x studs that attach to the 2x exterior sheathing and metal cloth screen (see Photographs 16 – 18 below). While probing the wall members with a scratch awl, it was noted that the wood was “soft”, indicating that the exterior surface of the members have exhibited decay and deterioration, which may result in a loss of structural capacity of the members.

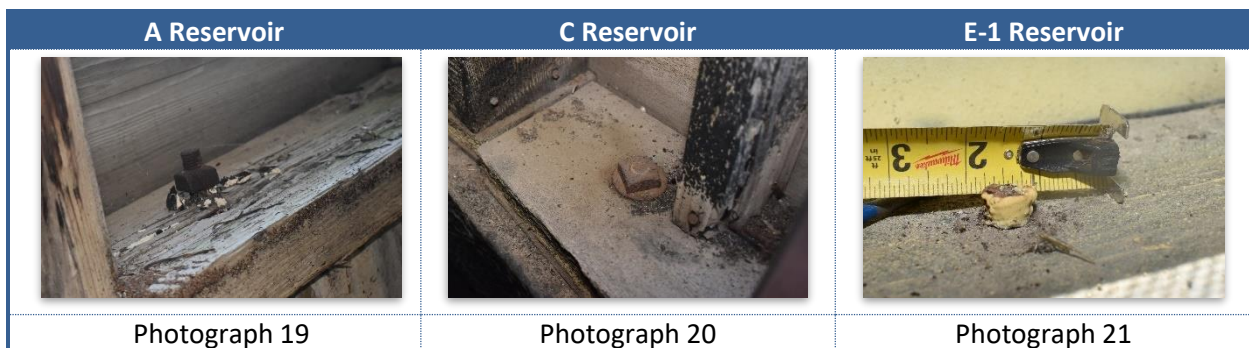
With the exception of E-1 Reservoir, the sill plate appeared to be anchored with a 5/8” diameter bolt and spaced on average at approximately 4’ on center as indicated in the historical drawings. At E-1 Reservoir, the anchors appeared to be spaced well in excess of 4’ on center and without the use of a nut or washer to create a positive connection to the wall below, indicating that the nuts may have either been lost/removed over time or potentially were not installed during construction. Surface rust and deterioration was noted at the bolts and nuts (see Photographs 19-21 below). In addition, what appeared to be signs of a termite infestation and corresponding damage was observed at the infill wall framing.

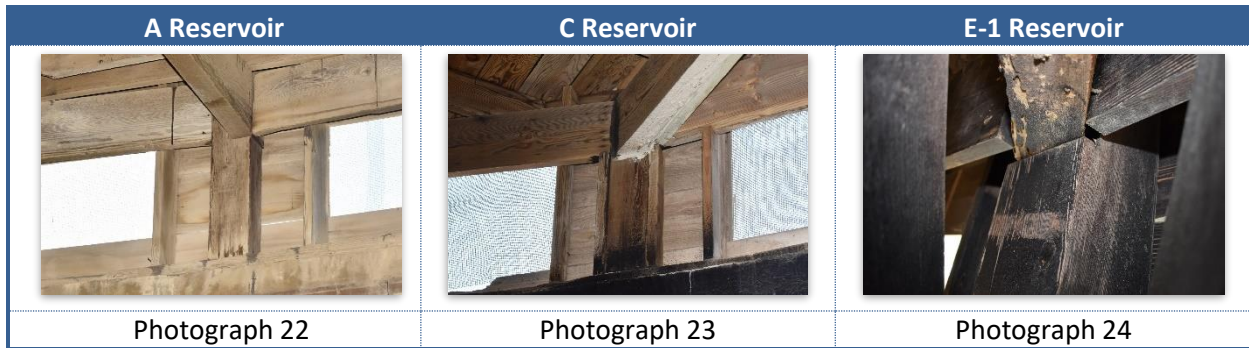
Where the 4x12 roof girders bear on the notched 8x8/6x6 wall posts, it was noted that the available notched space provided little to no bearing area for the perimeter 2x12 girders. In some cases, the 2x12 girders rely almost exclusively on nailing to the ends of the interior girders for transfer of roof loads to the posts (see Photographs 22 – 24 below). Given the deterioration of the 4x12 girder ends and the exposed shank, the connections do not appear adequate to transfer the roof loads to the posts and are a structural concern.

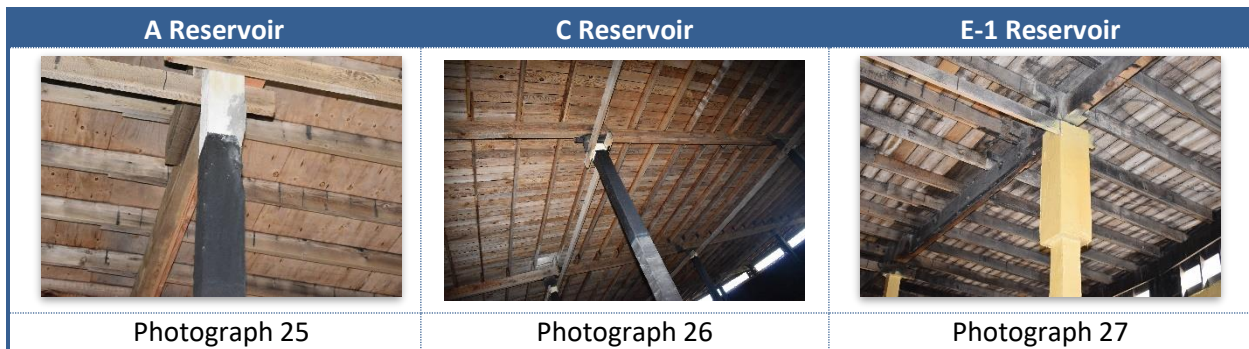
4.3.5 Columns

The interior concrete columns were confirmed to be 8" square in section as indicated in the historical drawings. Due to the presence of the liner around all the posts, we were not able to visually observe the condition of the concrete. The liner covers the entire column surface, thereby obstructing views to any cracking or minor deformations that may be present in the columns. However, it was noted that several of the posts had been modified/repared or showed loss of section, which appear to have occurred prior to, or at the time the reservoir walls and columns were lined (see Photograph 25 – 27 below).

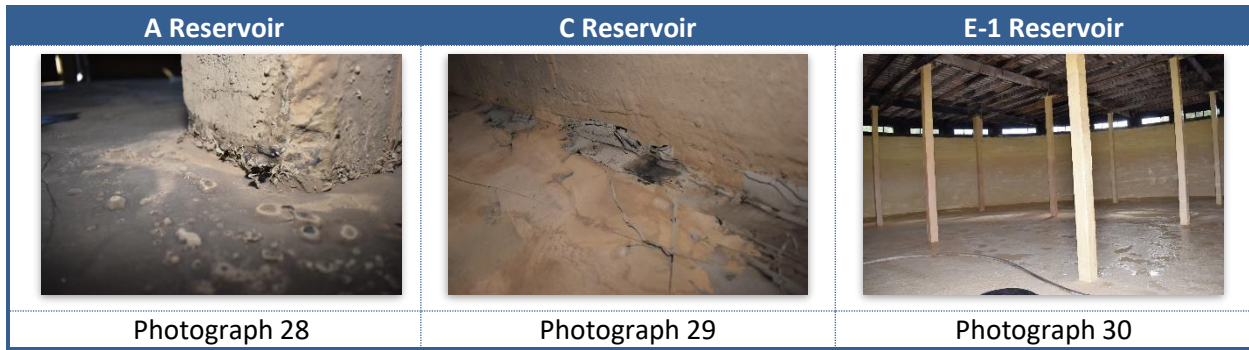
4.3.6 Slab Floor

Similar to the columns, the top surface of the interior floor slabs was observed to be coated with an interior liner, obstructing view to any minor cracking or deformations that may be present. Areas of bubbling, delamination, and patching of the liner was noted at various locations along the floors of A and C Reservoirs, typically near the base of the columns or perimeter wall (see Photographs 28 - 30). With the exception of a few areas of blistering near the perimeter wall, the liner at E-1 Reservoir appears in generally good condition.

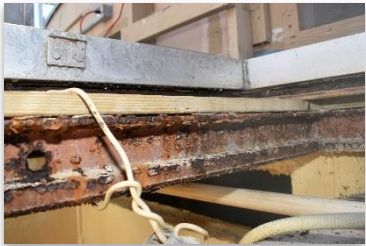
Photograph 40	Photograph 43	Photograph 45

The condition of the reservoir control boxes varied and were noted to be in generally serious to fair conditions. With the exception of the roof framing members, the control box at A Reservoir was noted to be in serious to poor condition. Based on conversations with District staff, we understand the control box roof framing at A Reservoir was recently replaced and based on PSE's observations, appears in good condition. Concrete spalling was observed at the top of the interior control box wall (see Photograph 40), at the overflow opening (see Photograph 41) during the inspection of A Reservoir. In addition, concrete staining and discoloration was observed near the top of the exterior control box walls of A Reservoir (See Photograph 42). We understand that when the existing roof was removed, concrete was formed and poured around the top of the existing wall as part of the installation of the new roof which is the likely cause for the staining and discoloration. The rebar was exposed at the overflow opening and showed significant deterioration.

The control box interior of C Reservoir, including portions of the steel roof framing was coated with a CIM liner, visibly obstructing ability to view any cracking or deformations that may be present. However, significant cracking at the overflow opening was noted during the inspection (see Photograph 43). While the CIM liner provides a protective coating, exposed areas of steel roof framing were noted to exhibit signs of moderate deterioration (see Photograph 44).

The control box interior of E-1 Reservoir was also coated with an epoxy liner, obstructing ability to view any cracking or deformations that may be present. However, moderate to severe corrosion and section loss of the control box roof framing was noted at the time of the observation (see Photograph 45).

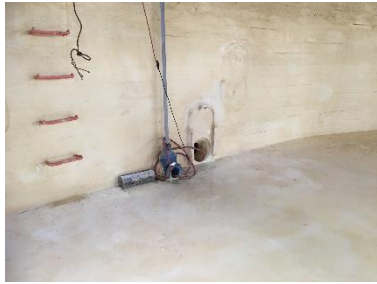
Photograph 47	Photograph 49	Photograph 51

- Around the entire circumference of the entire floor area, coating patching has taken place. The coating appears to have been ponded in excessive amounts to “push” the coating into the scrim along the joint between the floor slab and the base of the wall. Thus, there is a two to three-foot wide band of built up coating around the outer portion of the floor, along the entire wall circumference. Much of this coating is cracked or delaminated. See Photograph 49 below.
- The coating is delaminated at the base of several of the interior columns. See Photograph 48 below.

E-1 Reservoir: The existing Warren Environmental Epoxy applied in 2016 is in very good condition. There was only one location of observed coating delamination (less than 0.5 square feet in area). Less than 5 percent of the floor area has bubbling in the floor, but the bubbling has not resulted in any delamination. See Photographs 50 and 51 below.

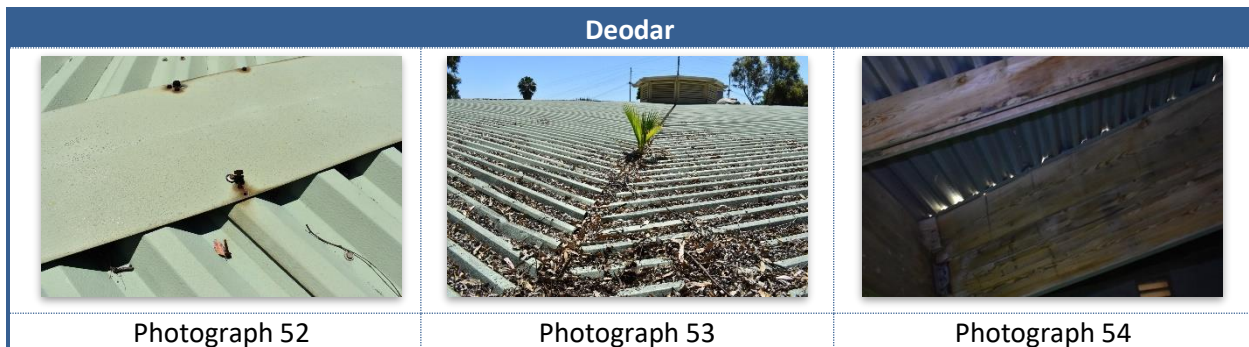
At the drain channels, a build up of debris has formed at the perimeter ends which has allowed for growth of plant life and is impeding the drainage of the roof (see Photograph 53). In its observed condition, the drain can be expected to overflow during times of heavy rainfall, allowing for water intrusion of the exterior portions of the valley glulam beams (shown later in the report). We understand that shortly after PSE's site visit, leaves and debris were cleaned out of the drain channels. In addition, light was observed at deck seams from the interior (see Photograph 54), indicating weatherproofing and water quality concerns.

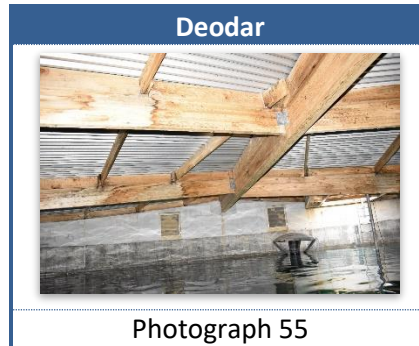
In general, the roof ridge beams as observed from the interior of the reservoir appeared in good condition. Minor water staining of the beam and CMU wall was observed (see Photograph 55) but overall the ridge beam and ridge beam connectors were noted to be in better condition than the valley and lateral Beams (described below).

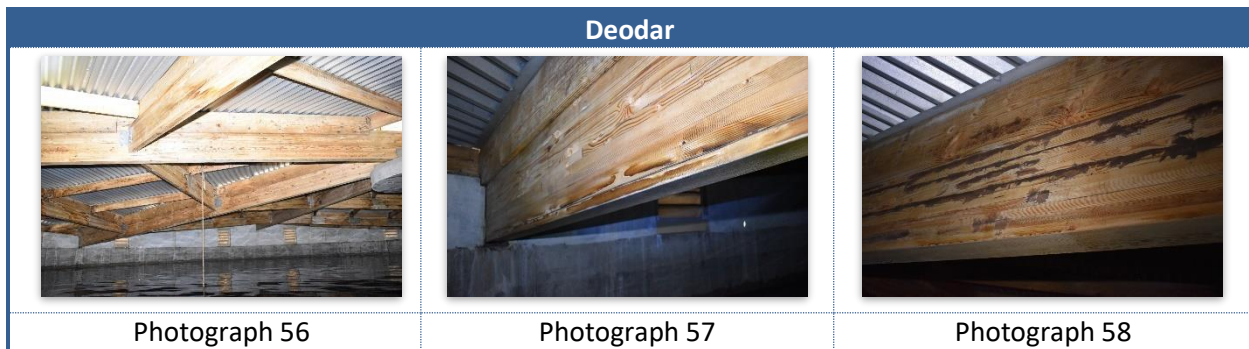
4.4.3.2 Valley Glulam Beams

In general, the roof valley beams as observed from the interior of the reservoir appeared in fair condition. Water staining was observed and appeared to get progressively more severe moving from the center column to exterior wall (see Photograph 56), indicating potential drainage and/or ventilation concerns. Minor delamination was observed at the valley beams but appears to mostly be present near the wall (see Photograph 57). In some cases, it appears the laminations were strengthened by means of epoxy injection (see Photograph 58). Moisture readings of the valley beams typically ranged from 13% - 18% with the exception of the valley beam east of the entry hatch opening which, measured a moisture content of approximately 23%. While probing the beams with an awl during the full/wet inspection, the wood that could be accessed was noted to be competent.

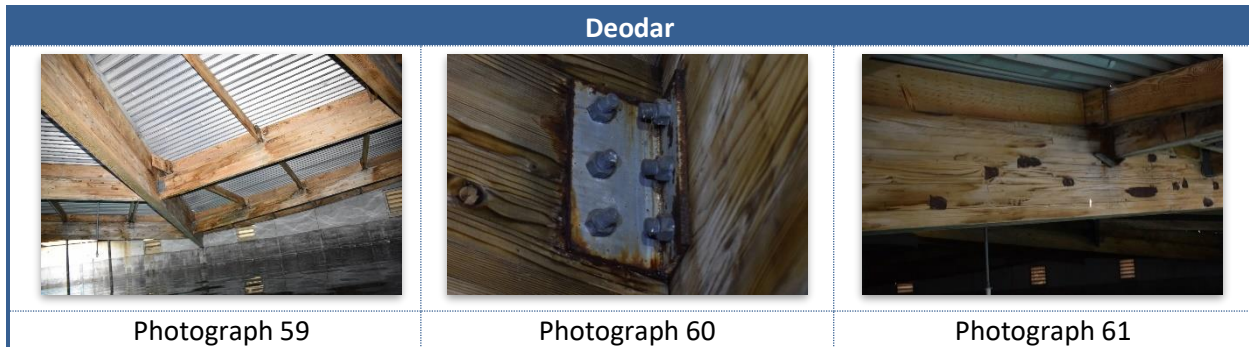
deterioration was noted at some of the lateral beam hardware (see Photograph 60). Minor delamination was observed at the valley beams. In some cases, it appears the laminations were strengthened by means of epoxy injection (see Photograph 61). Moisture reading taken of lateral beams ranged from 14% - 25%.

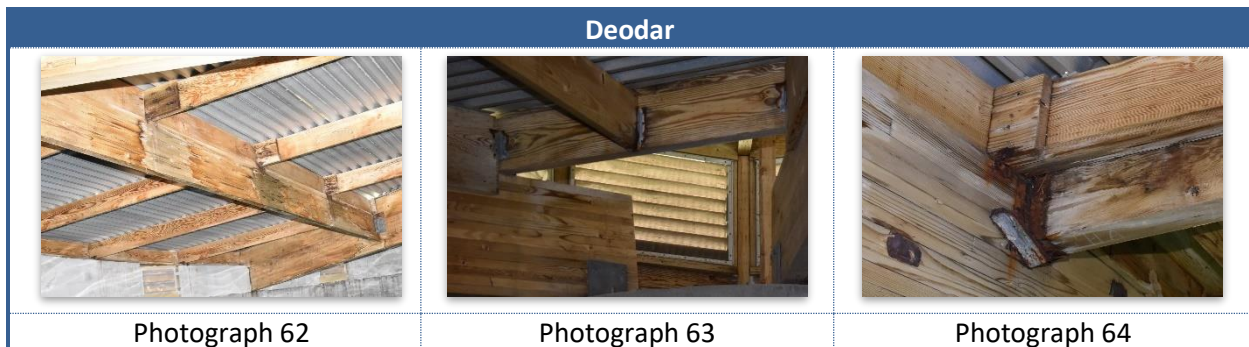
4.4.3.4 Rafters

In general, the roof rafters as observed from the interior of the reservoir appeared in poor to fair condition. Due to the limitations of the wet/full inspection, we were unable to closely examine the condition of all the existing rafters. Water staining and deterioration was observed and appeared to be concentrated at laps above lateral beams (see Photograph 62). Rafter hardware and connections appeared in generally poor conditions with moderate deterioration noted at most connections (see Photograph 63). In some extreme cases the hardware and connections have failed completely (see Photograph 64).

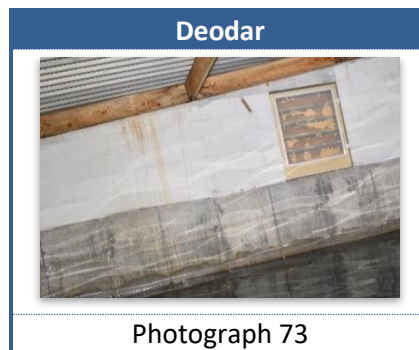
Photograph 73

The CMU walls were noted to be in generally good condition. Surface staining from the interior (see Photograph 73) was noted, indicating potential drainage and/or ventilation concerns of the roof framing.

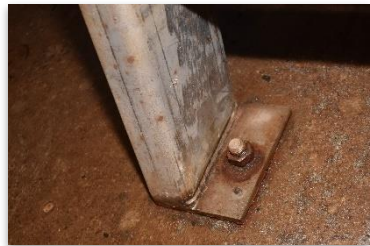
Photograph 78	Photograph 79	Photograph 80

and what appeared to be previous repair work of the overflow pipe was observed (see Photograph 78). Cathodic protection has been installed to control the corrosion of the overflow pipe and other metal surfaces and we understand new anodes were to be installed following our inspection. The overflow pipe was noted to be braced near the base slab. As the base slab is seismically isolated from the tank walls, this bracing condition could result in damage to the overflow pipe if the flexible coupling joint can't accommodate the imposed seismic deflections in a large seismic event which could significantly limit the capacity or results in the loss of the full storage capacity of the reservoir in immediate post-earthquake applications. Other metal surfaces had been coated with a protective layer (see Photograph 79), obstructing the condition of these elements. With the exception of these items, the internal appurtenances appeared in generally fair condition with some minor surface corrosion noted (see Photograph 80). Valves in the valve pit are in good condition. The sacrificial anodes appear to be working well in minimizing corrosion of the valves (see Photograph 81). The exterior appurtenances were found to be in generally good condition. No separation or failure of the elements were noted during the site observation, and coatings appeared intact. Minor corrosion blooms and rusting were noted at the fixed ladder (see Photograph 82).
